BEST PRACTICE

New tool to remove drive chamber insert from from mortar plant

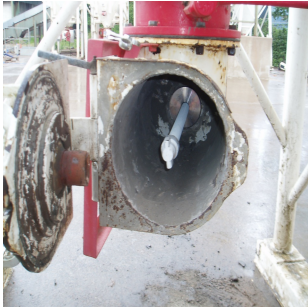
New method

Following this incident, a tool was developed by one of the engineers - a dry chamber insert extracting tool. The tool is simple to use and eliminates the need for any other tools. Utilising the motor of the silo, the insert can be removed in under a minute.

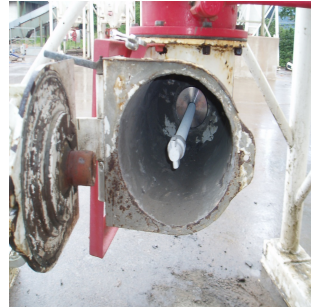
New method
