## BEST PRACTICE

LOCATION: Quarry  
ACTIVITY: Access & Egress & Working at Height  
SUB ACTIVITY: N/A  
BEST PRACTICE No: BP810  
COUNTRY OF ORIGIN: United Kingdom

**Creating safer access to a quarry crusher bowl and reducing working at height risks**

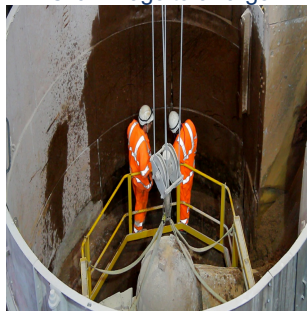
The solution to this problem was the construction of a safety guard rail assembly that can be lowered into place when entry into the crusher bowl is required.

- The guard rail assembly can quickly and easily be installed
- Maintenance operatives no longer required to wear fall arrest and restraint equipment
- Reduced risks associated with the need for scaffolding to be erected
- Reduces risk regarding slips/trips/fall, manual handling, stored energy (falling materials)
- Reduced production downtime.
