BEST PRACTICE

LOCATION: Quarry
ACTIVITY: Maintenance & Housekeeping
SUB ACTIVITY: N/A
BEST PRACTICE No: BP864
COUNTRY OF ORIGIN: United Kingdom

ARTICLE YEAR: 2013
COMPANY: Midland Quarry Products
COMPANY LOCATION: Cliffe Hill Quarry
COMPANY TEL: 07968 544064

Safe removal of shovel tooth from stalled primary gyratory crusher

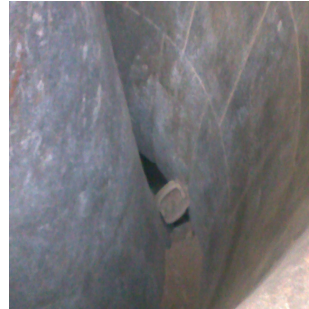
MPQ fabricated a purpose built, crescent shaped, steel plate to manage this risk when removing a bucket tooth trapped in the primary gyratory crusher at Cliffe Hill Quarry. Once all other materials had been removed the crusher, a jib crane lowered the purpose built plate into position over the trapped tooth. The lifting chains were left in place and to add more weight, the crane "block" was lowered onto the plate and a "Pecker" blade was also placed on it. A two man team, both wearing a safety harness, were positioned in the in the tipper box which had been previously cleared of all material. They used a thermal lance inserted between slots in the steel plate to dislodge the tooth.
