LOCATION:	Quarry	ARTICLE YEAR	2013
ACTIVITY:	Maintenance & Housekeeping	COMPANY:	Midland Quarry Products
SUB ACTIVITY:	N/A	COMPANY LOCATION:	Cliffe Hill Quarry
BEST PRACTICE No:	BP864	COMPANY TEL:	07968 544064
COUNTRY OF ORIGIN:	United Kingdom

**Safe removal of shovel tooth from stalled primary gyratory crusher**

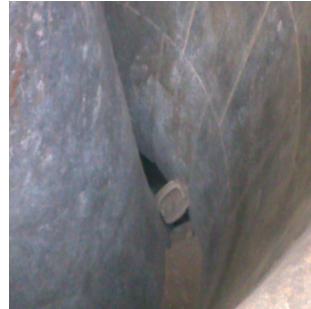
MPQ fabricated a purpose built, crescent shaped, steel plate to manage this risk when removing a bucket tooth trapped in the primary gyratory crusher at Cliffe Hill Quarry. Once all other materials had been removed the crusher, a jib crane lowered the purpose built plate into position over the trapped tooth. The lifting chains were left in place and to add more weight, the crane "block" was lowered onto the plate and a "Pecker" blade was also placed on it. A two man team, both wearing a safety harness, were positioned in the in the tipper box which had been previously cleared of all material. They used a thermal lance inserted between slots in the steel plate to dislodge the tooth.
