## BEST PRACTICE

**Probe to safely remove stones stuck between dump truck tyres**

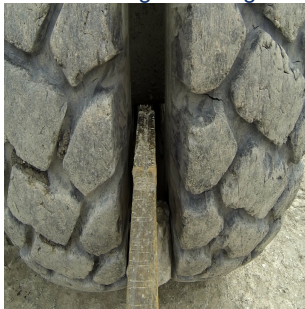
An engineering solution was designed and fabricated consisting of a large steel arm attached to the rear wall of an excavator bucket by means of a 'quick hitch coupler'. To remove wedged rocks, the dump truck operator contacts the excavator operator by radio and between them they position the truck so that the excavator can attach the probe and remove the rock.
