BEST PRACTICE

LOCATION:	Asphalt/Coating plant	ARTICLE YEAR	2013
ACTIVITY:	Maintenance & Housekeeping	COMPANY:	Aggregate Industries
SUB ACTIVITY:	N/A	COMPANY LOCATION:	Moorcroft Asphalt
BEST PRACTICE No:	BP895	COMPANY TEL:	07733 300271
COUNTRY OF ORIGIN:	United Kingdom

Clearing blockage using a Thermowrap system

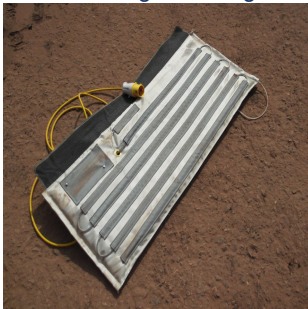
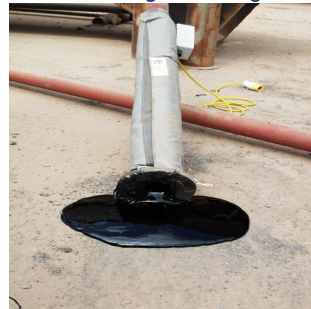
The solution has been to use the Bitumen Thermopipewrap System. This is a simple heated mat, inspired by Formula 1 tyre heater technology, it is wrapped around the item to be warmed, is fixed into position utilising a Velcro system and then plugged in to either 110v or 240v electrical feed. The Thermowrap heats up to the pre-set temperature and the solidified bitumen in the pipe, valve or pump then turns back into fluid state and flows out using gravity. The flow of bitumen is slight as the temperature rises so removal is under tight control at all times.
