# UK Safety Alert

## Entanglement With a Pillar Drill Results in Broken Thumb

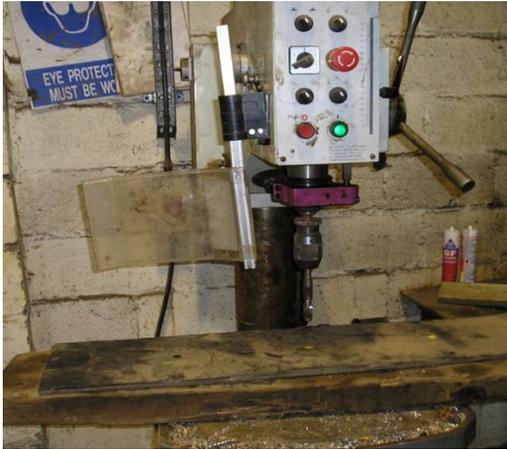
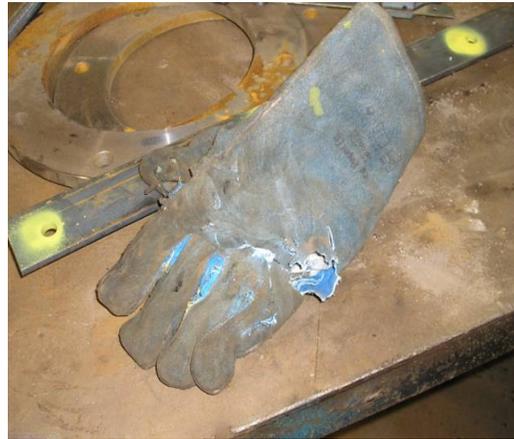
A Fitter sustained a broken thumb, following an entanglement incident involving a conventional pillar drill. As the Fitter was drilling a metal workpiece, a section of swarf from the drill bit caught and entangled his “glove”, fortunately he was able to activate the emergency stop and deactivate the drive mechanism.

Upon investigation it appears the workpiece was not clamped to the drill table, that the interlocked guard may not have been fully engaged, and that the spindle guard interlock mechanism was faulty. Further and crucially the Fitter was wearing welding gauntlets and placed his hand in close proximity to the unguarded rotating drill bit.

- Ensure the effective **safeguarding of moving parts by guarding where practicable**. Do your drilling machines have guards, interlocks and trips fitted? Are they fully operational and form part of **workplace inspections**?

- Have in place suitable arrangements and equipment to **secure the clamping of the workpiece**.
- Have in place **safe systems** to demonstrate that operators (be they employees or third party contractors) are adequately **trained, supervised** and **authorised** to use specialist equipment.

- Appreciate that inappropriate PPE can increase the risk of entanglement. Nearly half of all drilling machine accidents involve the entanglement of inappropriate gloves. A **PPE risk assessment should** ensure that no loose clothing should be worn, and that gloves selected should be less likely to be entangled and tear relatively easily, employers should consult with their PPE supplier where necessary.

- Have in place safe systems of work based on the findings of a **full risk assessment**. Whilst not exhaustive such safe systems would ensure that operators are fully trained, have read the manufacturers instructions, report defective equipment, do not operate equipment with loose clothing, bandages or rings and maintain good housekeeping standards in and around the workshop and drilling equipment.
